Emmtec

Cleaning of 26 MW turbo rotor – 2015

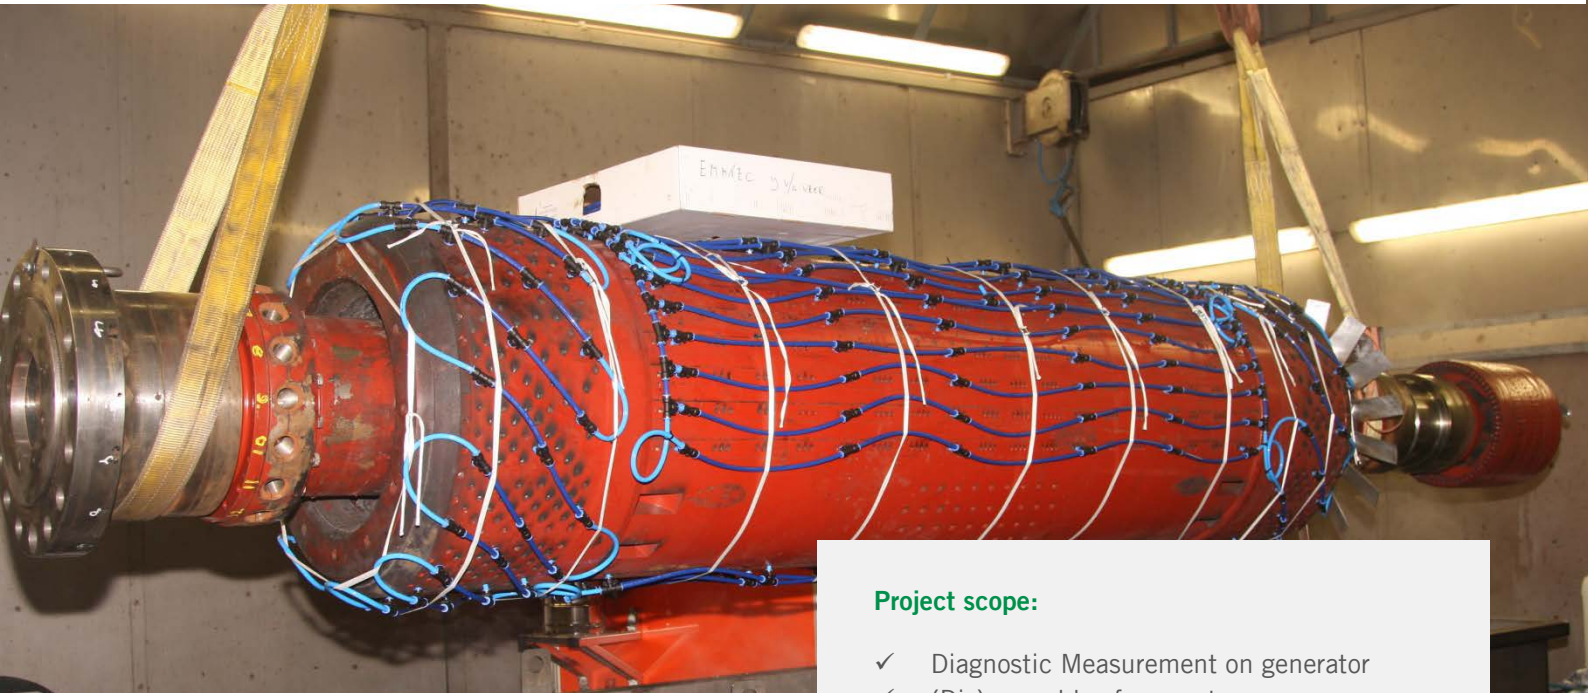
Diagnostic measurement: turbo rotor strongly contaminated

While performing a diagnostic measurement on the generator, Bakker Repair + Services detected that the turbo rotor was strongly contaminated. This resulted in low resistance. In consultation with Emmtec, we decided to disassemble the generator and to clean the 26 MW turbo rotor at Bakker Repair + Services's workshop.

To clean the turbo rotor, we immersed it in a bath filled with water and detergent. A custom designed air flow system cleaned the ventilation holes of the turbo rotor with air bubbles. Therefore air tubes were mounted on the turbo rotor. Afterwards, we dried the turbo rotor in our dry oven. After cleaning, the resistance increased significantly.
