Linde Gas

Rewinding 16,5 MW motor – 2018

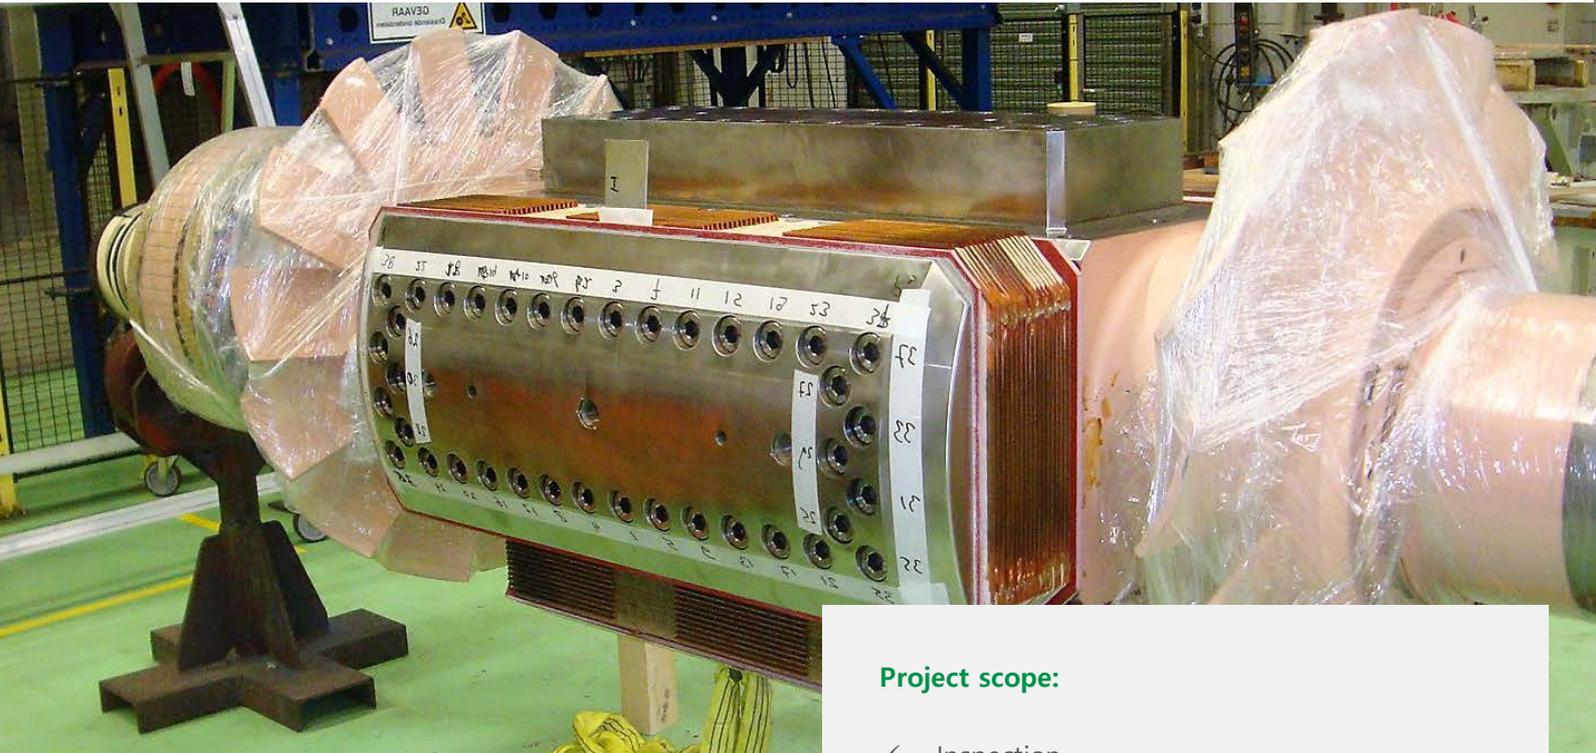
Bakker Repair + Services managed to repair a 16,5 MW motor from Linde Gas within a record time of three weeks. We came to the rescue when Linde Gas's own supplier needed more than six weeks to deliver the defected part.

The 16.5-megawatt electric motor is essential to Linde Gas for the production of nitrogen for natural gas at its production site in IJmuiden. Since the motor failed, an old motor with less capacity had to take over, but this situation could not last too long. When Linde Gas's own Original Equipment Manufacturer (OEM) indicated he needed six weeks or more to supply the vital coil of the rotor, the company called its maintenance and repair partner Bakker Repair + Services. Bakker duplicated the part and repaired the motor in half the lead time, thus helping out Linde Gas.

The 35-tonne giant motor was dismantled at the production site in IJmuiden and transported with special road transport to Sliedrecht. There, the new part was built in and the motor was repaired. Due to the urgency of the repair, Linde Gas used Bakker's 24/7 service. That company worked seven days a week, 20 hours a day, to complete the project. Within three weeks, the repaired motor was transported back to Linde Gas IJmuiden and reinstalled on site.
