Suikerunie

Replica 15 MW generator

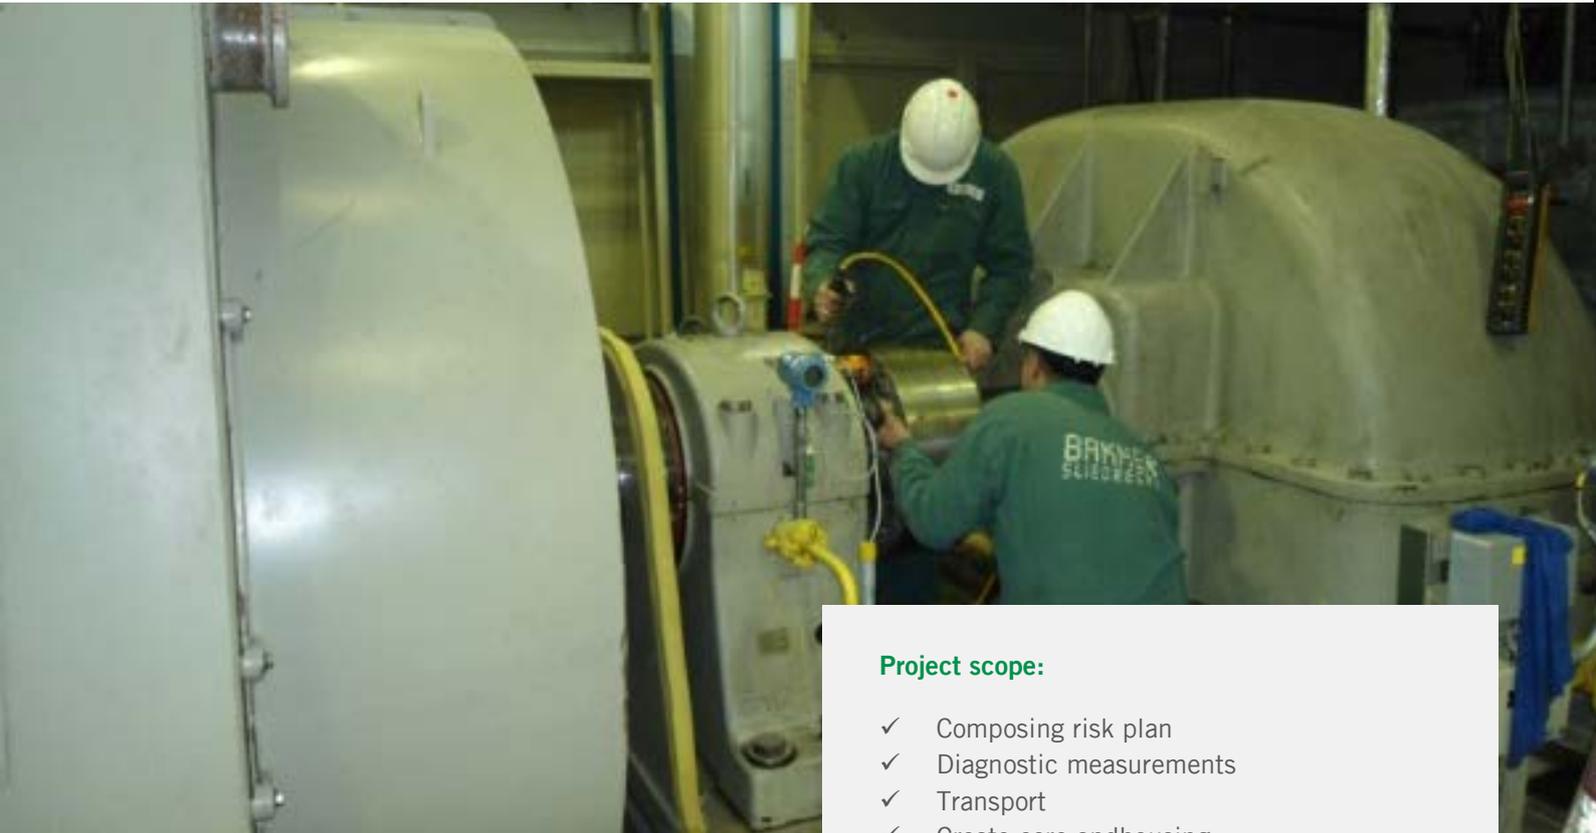
Suikerunie relies on a 15 MW generator for the production of sugar for consumers and the food industry. Bakker Repair + Services provides Suikerunie insight in the condition of this machine by performing a diagnostic measurement yearly. This periodic measurement showed that the condition of the stator winding was badly deteriorated. Bakker Repair + Services advised the Suikerunie to rewind the complete stator.

Upon arriving in the workshop the generator was given an extra thorough inspection which revealed a core failure. In close consultation with Suikerunie it was decided to build a replica of the housing and the core. This meant that the specialists of Bakker Repair + Services had to pile up 14.000 segments by hand.

Bakker Repair + Services built a replica of the housing and the core and rewound the stator in just 3 months time. The transport of the generator and the alignment on site were also carried out by Bakker Repair + Services. In this way Suikerunie did not have to worry about a successful completion of the project. The replica of the generator was successfully delivered turnkey on time within the agreed budget.
